Manhole Inspection Summary

Manhole # S13C__038MH

Insp Date: **1/9/09 2:03 PM**

Location Address: **600 POPLAR GROVE ST**

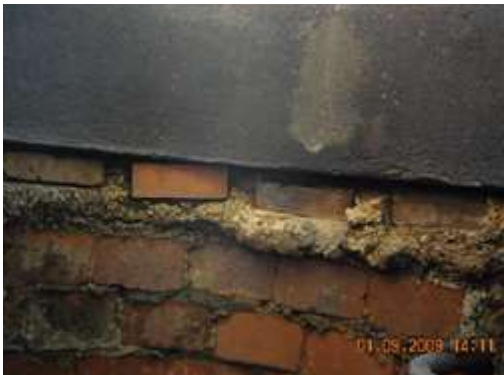
Defect 1

Condition: ☐ Sound ☒ **Cracked** ☐ Root Intrusion ☐ Loose Brick ☒ **Deteriorated**

CHIMNEY ADJUSTMENT 6"
DETERIORATED

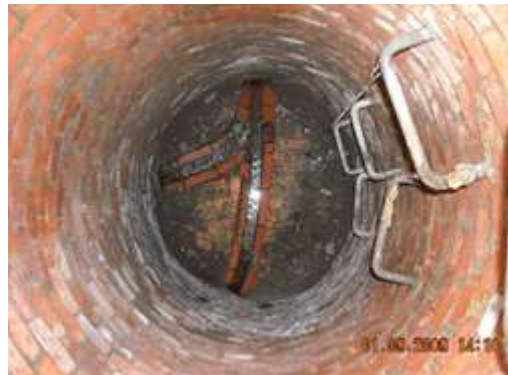
Defect 2

Infiltration: ☐ None ☐ Joint ☐ Cracks ☐ Mortar ☐ Roots ☒ **Wall**

☒ **Evidence Of Surcharge** Depth: **1** (ft.) ☐ Active Surcharge Present

evidence surcharge; corroded step;
infiltration barrel

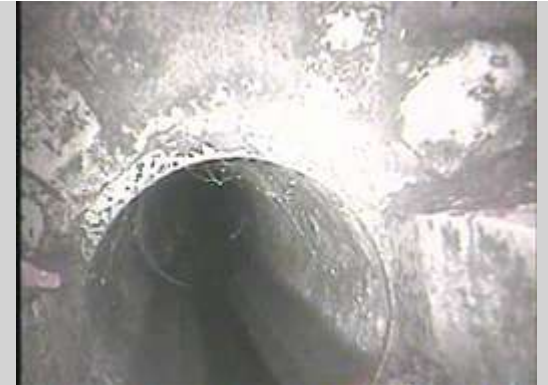
12 O'Clock Outflow

8 in. Circular Gravity Sewer
Pipe Out @ 12 O'Clock

Pipe Height: **8.4** (in.) Rod and Bar (Angled)
Pipe Material: **Clay** ☐ Pipe Lined
Invert Depth: **10.24** (ft.) Flow Characteristics: **Slow**
Deposits: ☐ None ☐ Mud ☒ **Sludge** ☐ Debris ☐ Grease
Silt Depth: **1** (in.) Deposits Extent: **Light**
Infiltration: **None** Pipe Seal Cond: **Sound**

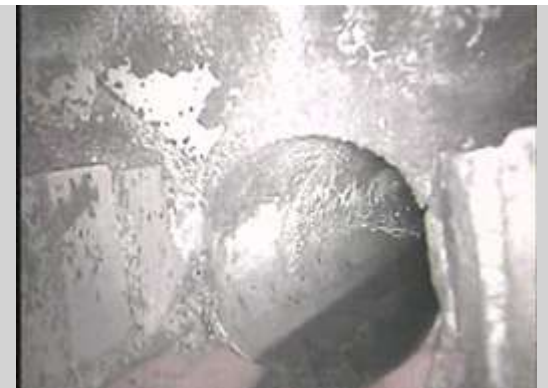
6 O'Clock Inflow

6 in. Circular Gravity Sewer
Pipe In @ 6 O'Clock

Pipe Height: **6** (in.) Rod and Bar (Angled)
Pipe Material: **Clay** ☐ Pipe Lined
Invert Depth: **10.20** (ft.) Flow Characteristics: **Slow**
Deposits: ☐ None ☐ Mud ☒ **Sludge** ☐ Debris ☐ Grease
Silt Depth: **1** (in.) Deposits Extent: **Light**
Infiltration: **None** Pipe Seal Cond: **Sound**

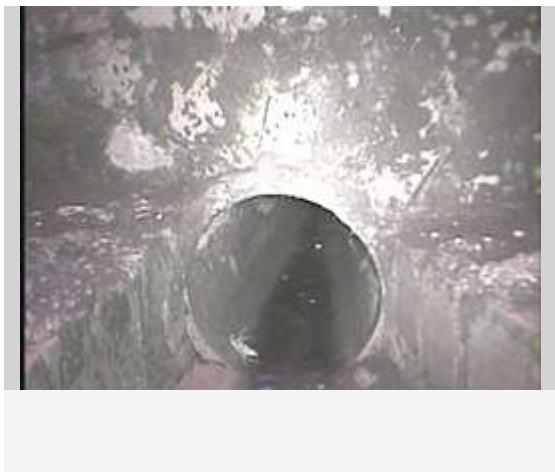
9 O'Clock Inflow

6 in. Circular Gravity Sewer
Pipe In @ 9 O'Clock

Pipe Height: 6 (in.) Rod and Bar (Angled)
Pipe Material: Clay ☐ Pipe Lined
Invert Depth: 10.14 (ft.) Flow Characteristics: Slow
Deposits: ☐ None ☐ Mud ☒ Sludge ☐ Debris ☐ Grease
Silt Depth: 1 (in.) Deposits Extent: Light
Infiltration: None Pipe Seal Cond: Sound
